INDOOR AIR QUALITY ASSESSMENT

**Newman Elementary School
1155 Central Street
Needham, Massachusetts 02492**

Prepared by:
Massachusetts Department of Public Health
Center for Environmental Health
Emergency Response/Indoor Air Quality Program
May 2007

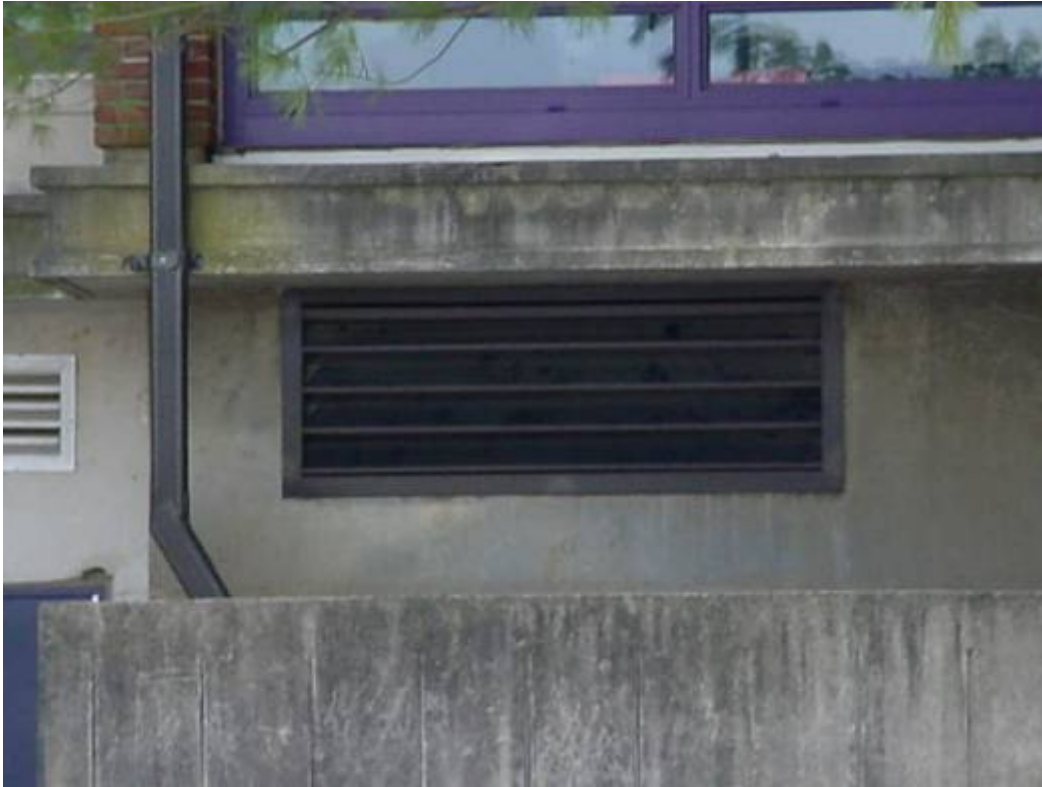
Picture 1

Outside Air Intake for Mechanical Ventilation System

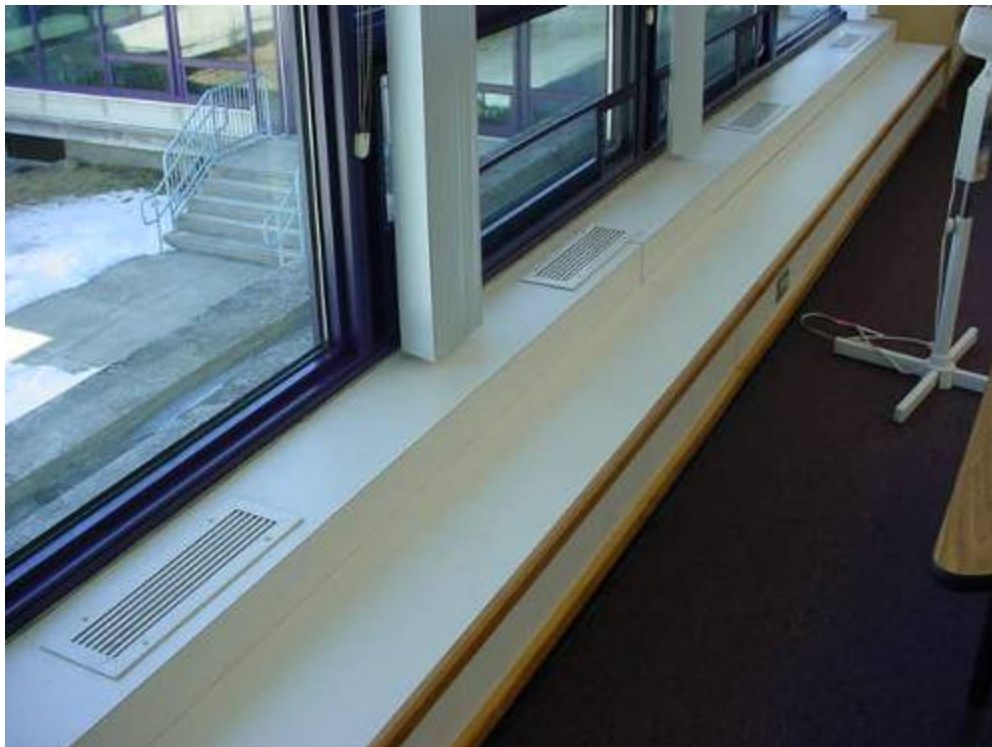
Picture 2

Supply Vents along Exterior Wall of Classroom

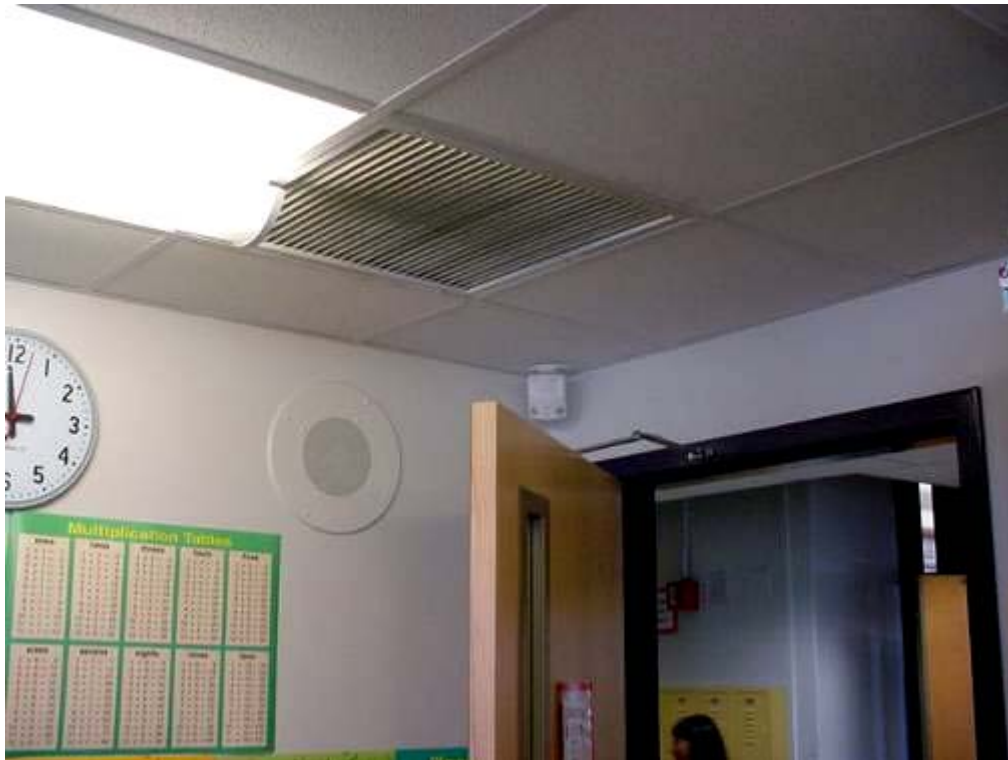
Picture 3

In some cases, the efficiency of exhaust vents is limited by their location in the classrooms (Picture 3). In several classrooms, exhaust vents are located above hallway doors. When classroom doors are open, exhaust vents will tend to draw air from both the hallway and the classroom reducing the effectiveness of the exhaust vent to remove common environmental pollutants.

Several personal fans and return/exhaust vents were occluded with dust and debris (Pictures 3 and 8). Dust can be a source for eye and respiratory irritation. If exhaust vents are not functioning, backdrafting can occur and aerosolize dust particles. Re-activated personal fans can serve to distribute dust.

Ceiling-Mounted Return Vent, Note Dust Accumulation and Proximity to Open Classroom/Hallway Door

2. Work with HVAC vendor to examine methods of increasing fresh air intake.
3. Remove all obstructions from supply and exhaust/return vents to facilitate airflow.

15. Clean exhaust/return vents and personal fans of accumulated dust periodically to prevent the aerosolization of dirt, dust and particulates.
16. Ensure water is poured into the restroom floor drain in room 132 every other day (or as needed) to maintain the integrity of the trap.

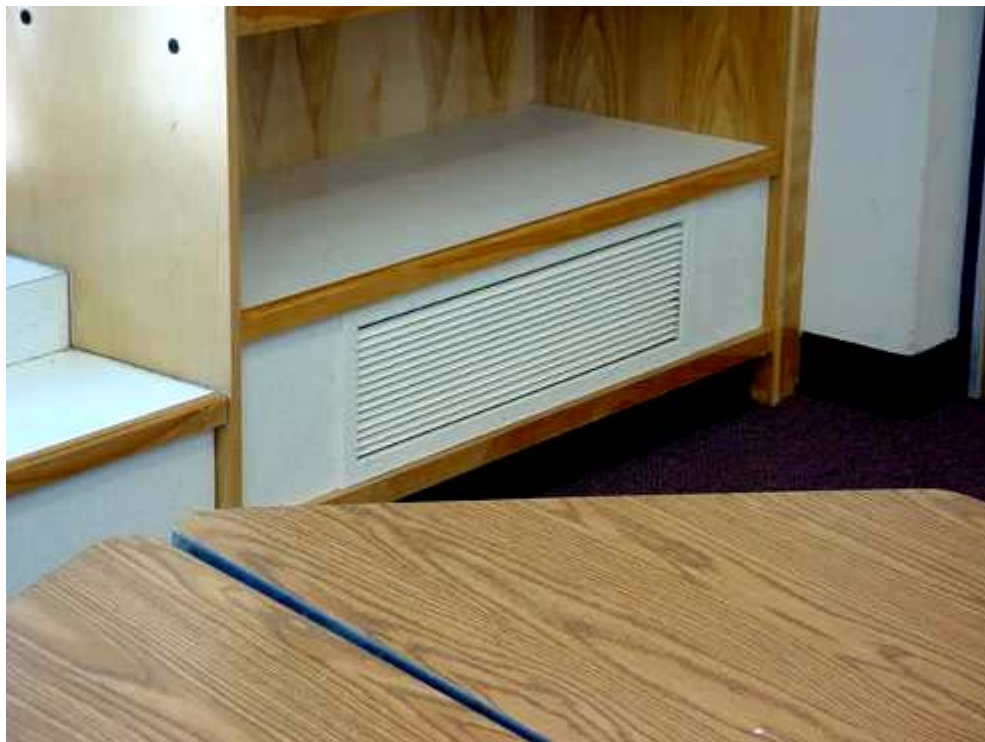
Picture 4

Wall-Mounted Return Vent

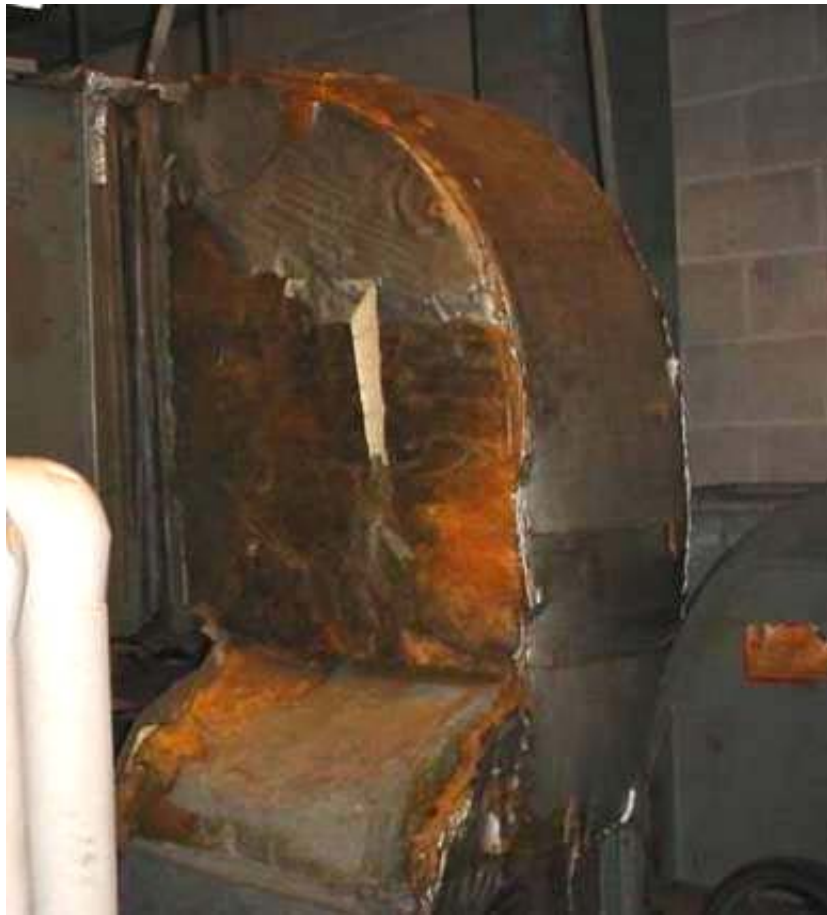
Picture 5

spaces are typically experienced, even in a building with an adequate fresh air supply. CEH staff observed that insulation around ductwork in the lobby fan room was damaged/missing (Picture 5), which can make temperature control difficult.

Missing/Damaged Insulation around Ductwork in Lobby Fan Room

7. Replace damaged ductwork insulation in lobby fan room shown in Picture 5.
8. Change filters for HVAC equipment as per the manufacturer's instructions or more frequently if needed.

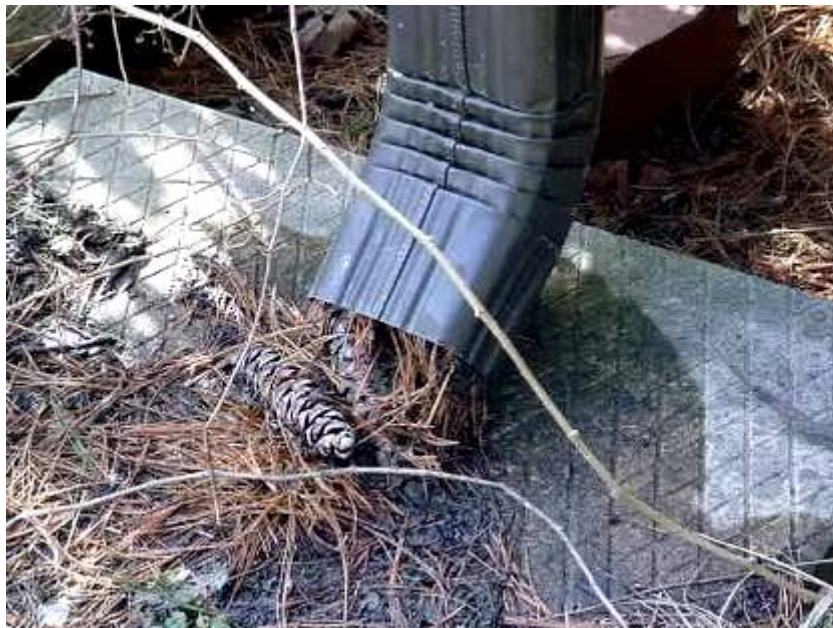
Picture 6

CEH staff examined conditions on the exterior of the building for potential sources of water pooling/penetration. Several gutters and downspouts were observed as clogged with pine needles and other debris (Picture 6). To ensure proper drainage, school maintenance staff should inspect and clear debris periodically.

Downspout Clogged with Pine Needles and Other Debris

10. Inspect gutters and downspouts around the perimeter of building periodically for proper drainage, clear debris as needed.

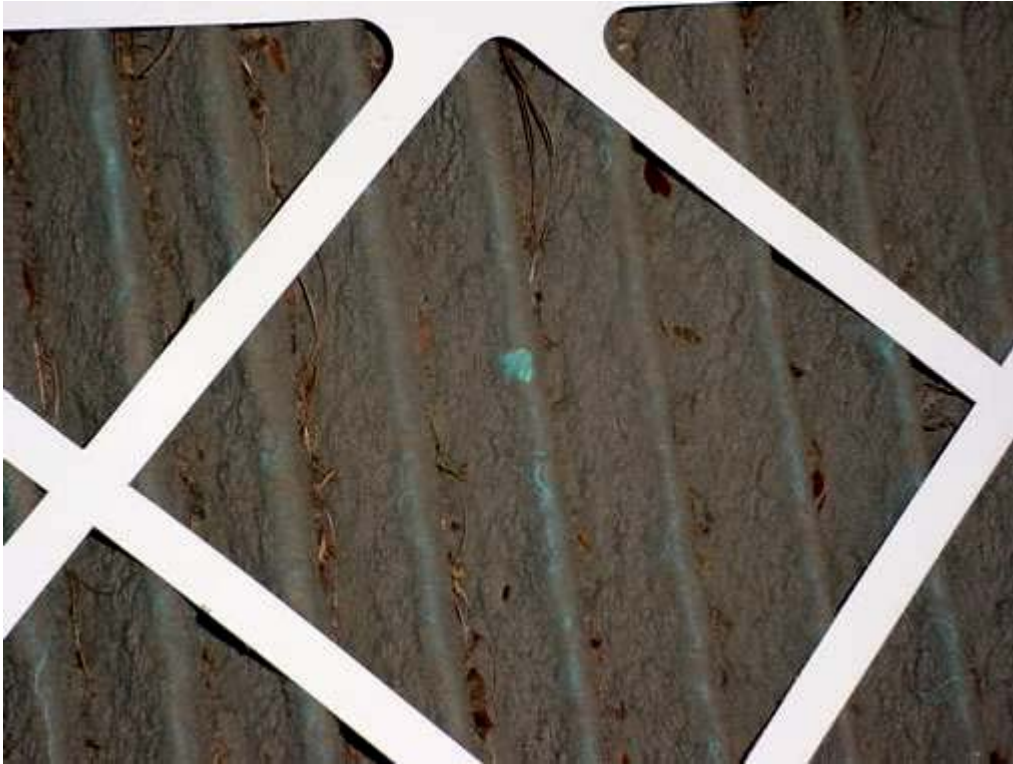
Picture 7

Other conditions that can affect indoor air quality were observed during the assessment. Filters for AHUs are reportedly changed by the Needham Department of Public Facilities once a year. CEH staff examined filters for the AHU in the lobby fan room from which the steam leak

originated and observed the filters were occluded with dust and debris (Picture 7). Filters should be changed as per the manufacturer's recommendations or more frequently if needed. Saturated filters can actually *serve* as a reservoir for dust and particulates to be distributed by the ventilation system.

Filter Clogged with Dust and Debris in Lobby Fan Room

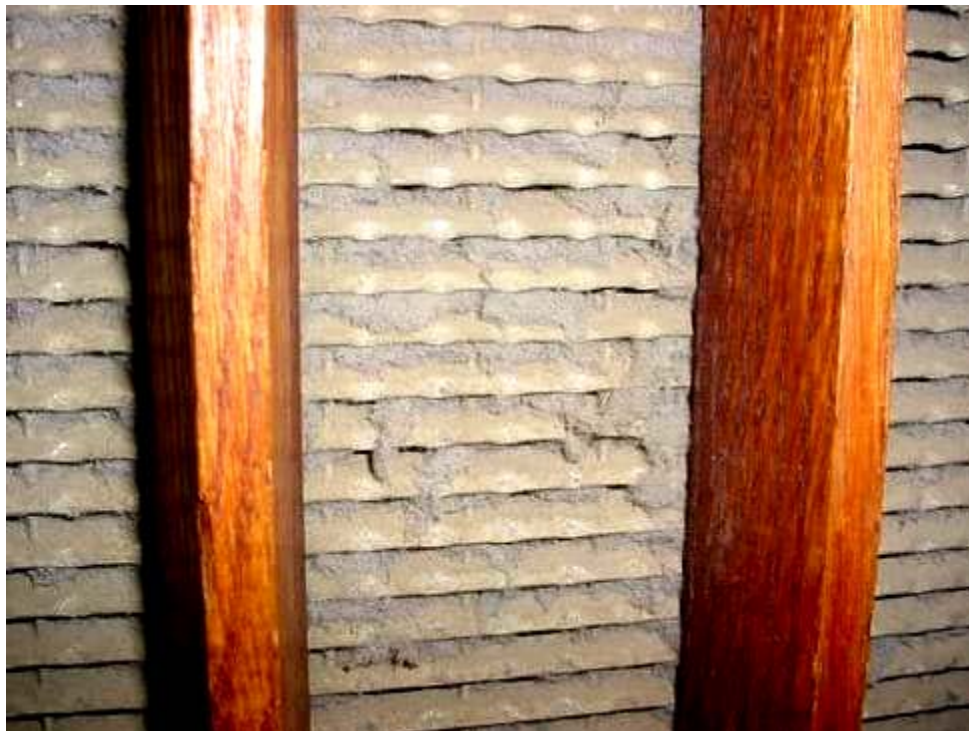
Picture 8

Dust Accumulation in Gymnasium Exhaust Vent
